Cross-section Paint Microscopy Report

Exterior Paints and Washes -- Phase II

**The Montpelier Foundation
Montpelier Station, Virginia**

Date: July 1, 2005

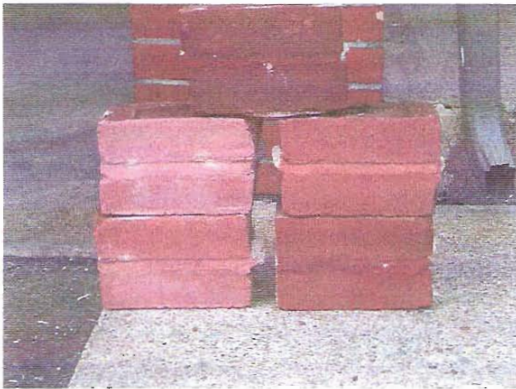
Freshly painted mock-ups February 2005

I later took these mock-ups and left them outside to monitor the resistance of the various mock-up coatings to weathering (snow, rain, ice, and freeze-thaw cycles). The results after approximately 16 weeks of weathering show that there is little appreciable change in the surface and color of any of the mock-up washes, despite the difference in pigment to lime ratio. The photographs below look slightly different because they were taken under different illumination conditions.

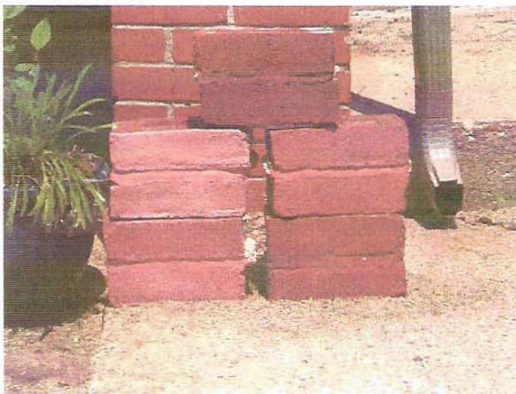
Mock-ups on June 16, 2005
