MEMO

RE: Somerset Red Wash

DATE: March 30, 2006

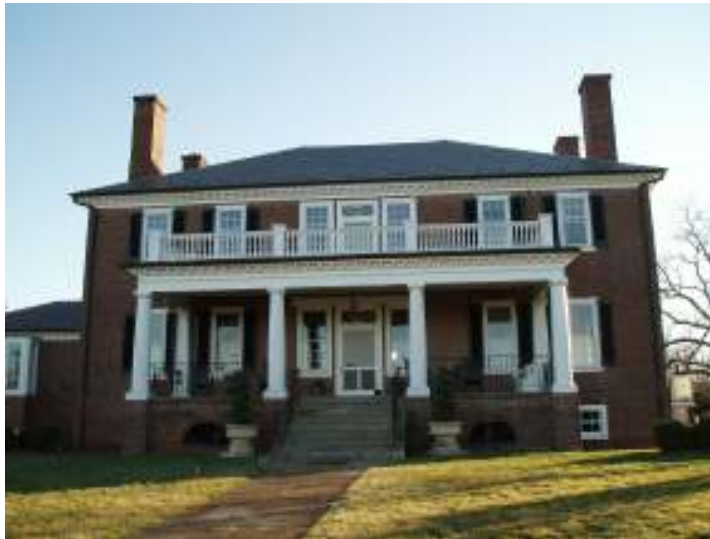
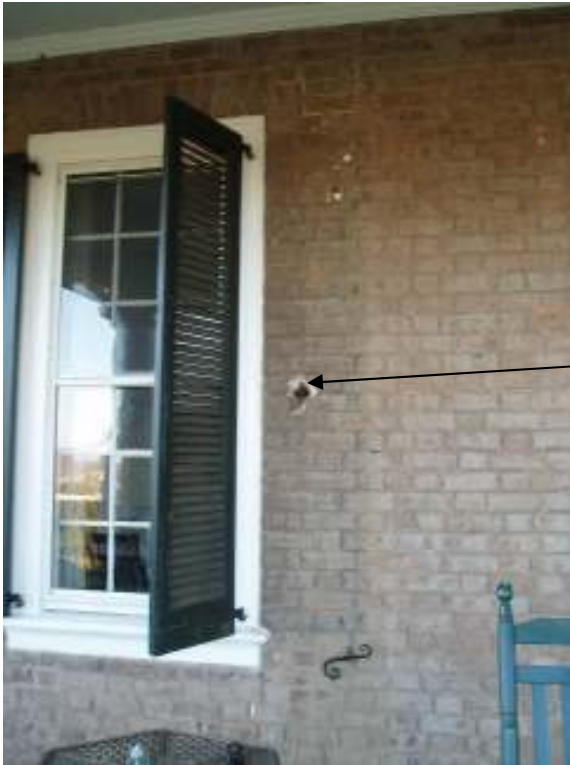
Sample taken at edge of existing hole where brick was protected by the open shutter

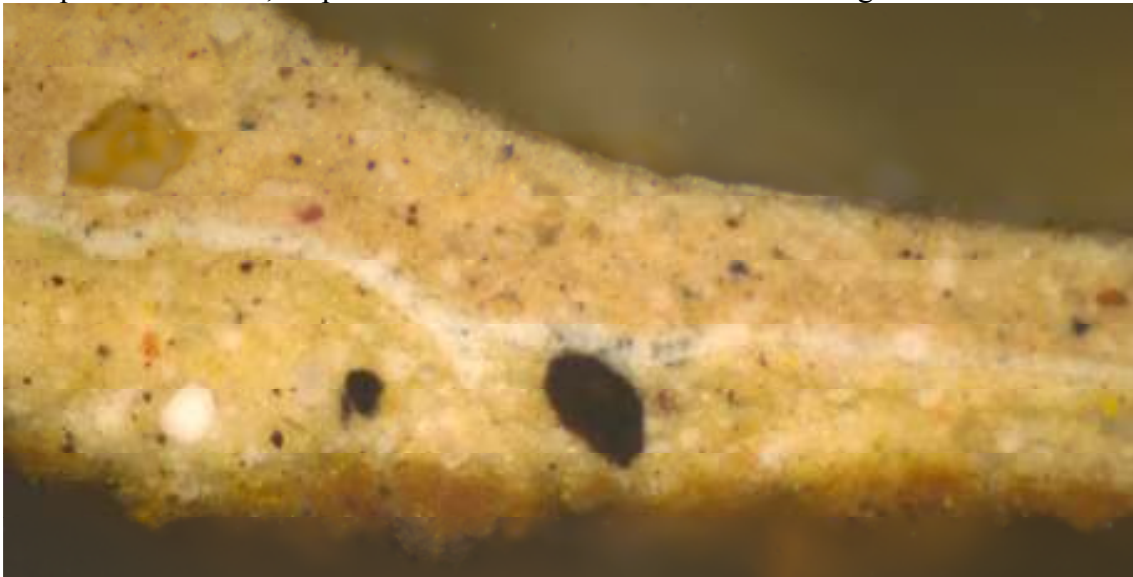
Sample 1. Somerset, on protected brick behind shutter. Visible Light 200X

The layers are so chalky that it was not possible to retrieve a sample with the brick substrate still attached: the cleavage is taking place at the degraded orange-red wash layer directly on top of the brick. The evidence in sample 1 shows that there are four generations of chalky, slightly translucent washes remaining. The first layer is an eroded orange-red wash layer which is followed by a thick dark tan layer, then a thin grayish-white. The fourth generation paint is a more opaque grayish-brown coating. Staining with biological fluorochrome stains shows that the first orange-red layer does not contain protein or carbohydrate components, but the uppermost coating does have a weak protein component.

It was difficult to discretely separate the first orange-red layer for pigment analysis using polarized light microscopy because it is so fissured and degraded. However, in cross-section this layer appears to be a relatively even mix of red ochre and calcium carbonate. SEM-EDS analysis with elemental mapping, like the analysis conducted for a number of the Montpelier red wash samples and one sample red wash from UVA Pavilion VIII, would show the specific distribution of elements in each layer. This preliminary cross-section analysis suggests the first red wash layer is consistent with a very weathered red-pigmented limewash, followed by three more pigmented limewash coatings of varying colors.

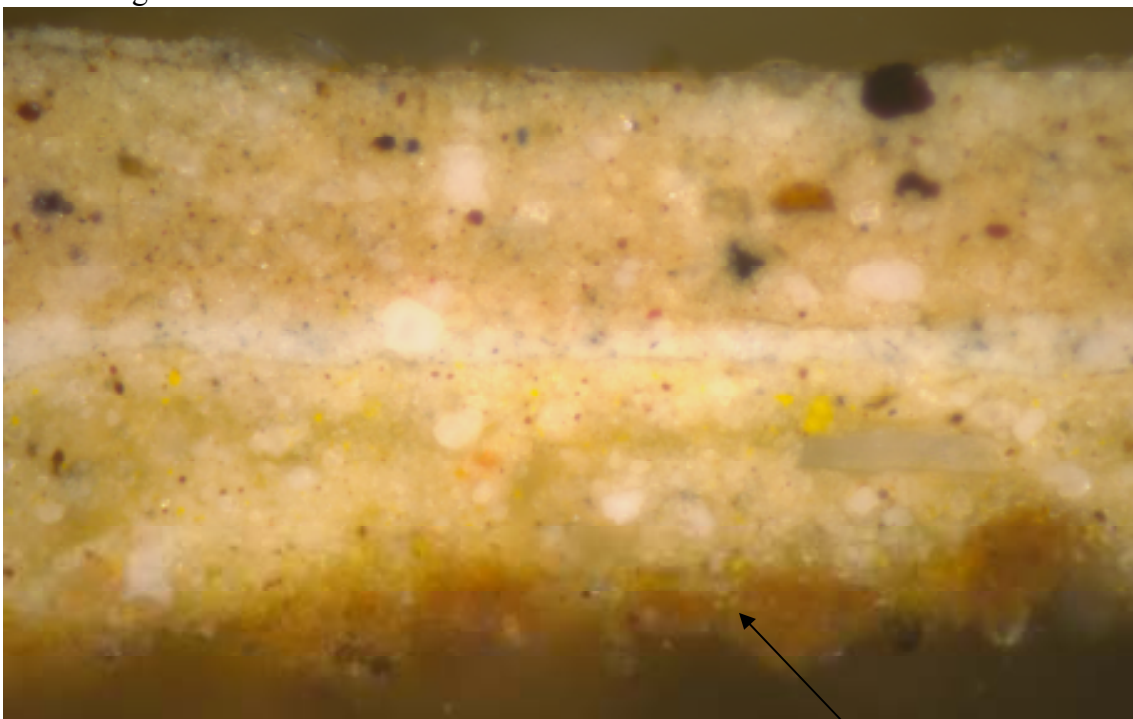
Visible Light 400X

Eroded reddish wash

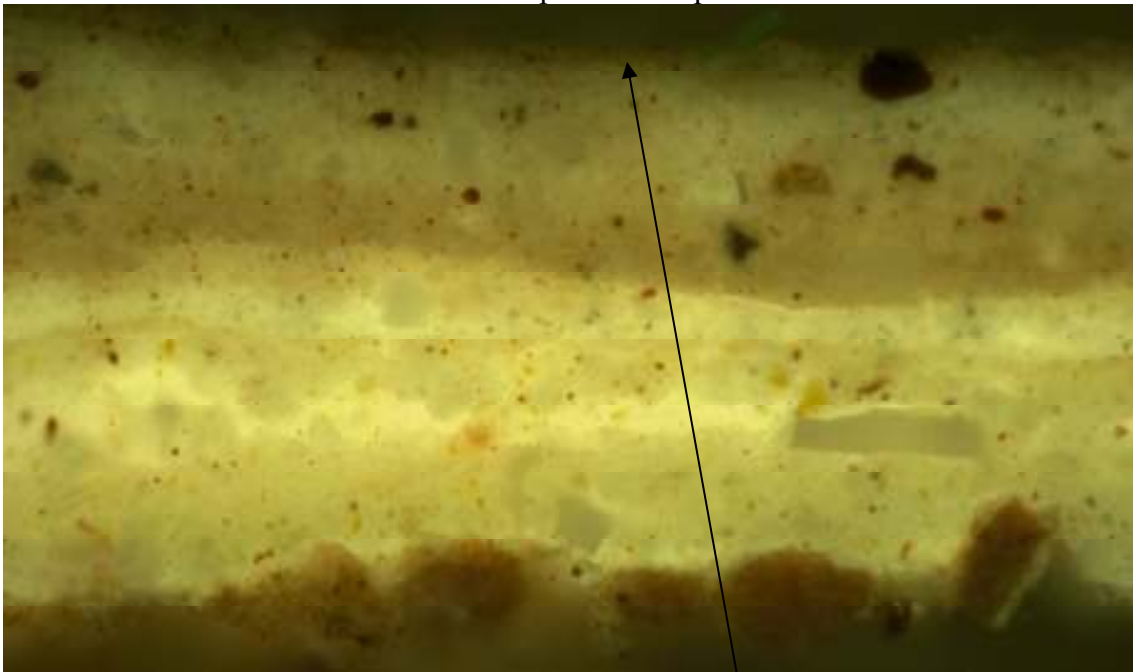
BV-2A filter and Alexa Fluor 488 for the presence of proteins 400X

Weak positive reaction for the presence of proteins in the uppermost layer
