Sample VIII-2. Brick face 3” below south (right) front window sill, first floor. This sample was taken from an area noted by Mark R. Wenger as representative of the red-washed surfaces identified by Dr. Gerard Lynch as typical of a “colour wash” (not a limewash), based on visual examination. In cross-section there is a thin, uneven, dark red layer on the surface of the brick substrate. It is difficult to confidently determine the composition of this wash layer using only light microscopy as it is so thin and has penetrated into the brick substrate. However, there is no dirt trapped between the red wash layer and the brick, suggesting this coating was applied before the surface had aged or weathered.

Red Wash Comparison at 50X magnification

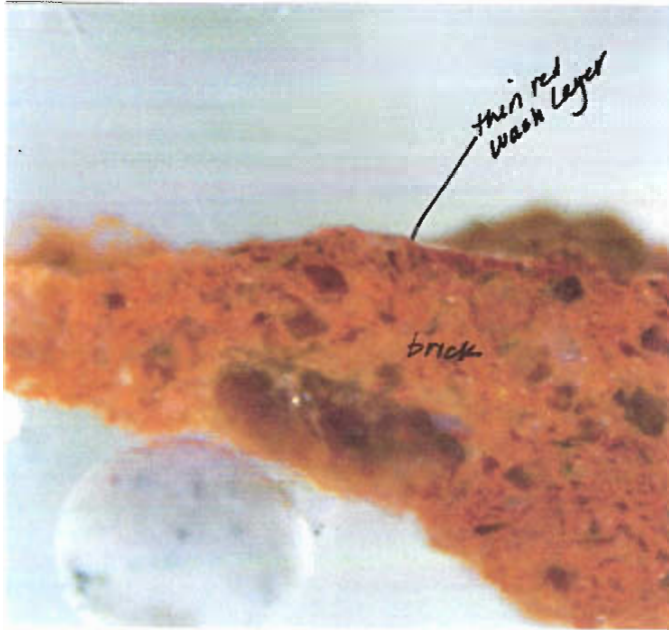
Visible Light 50X

Sample VIII-2. Brick face 3" below south (right) front window sill, first floor Wayne Mays' "colour wash" mock-up'

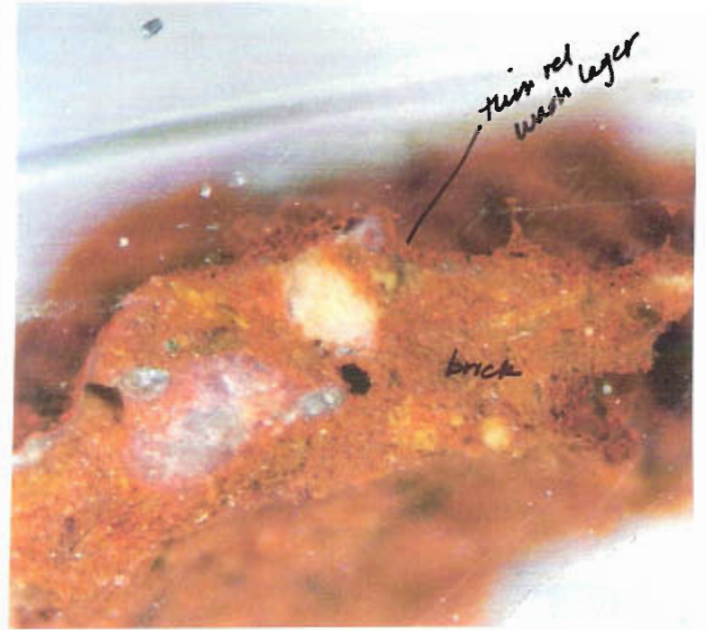
Visible Light 50X

The appearance of the thin red layer in cross-section is very similar to the cross-section sample of the brick mock-up painted by Wayne Mays in October 2004 composed of iron oxide pigments, water and a small proportion of dilute hide glue. (See page 91 of the December 14, 2004 cross-section microscopy report.)

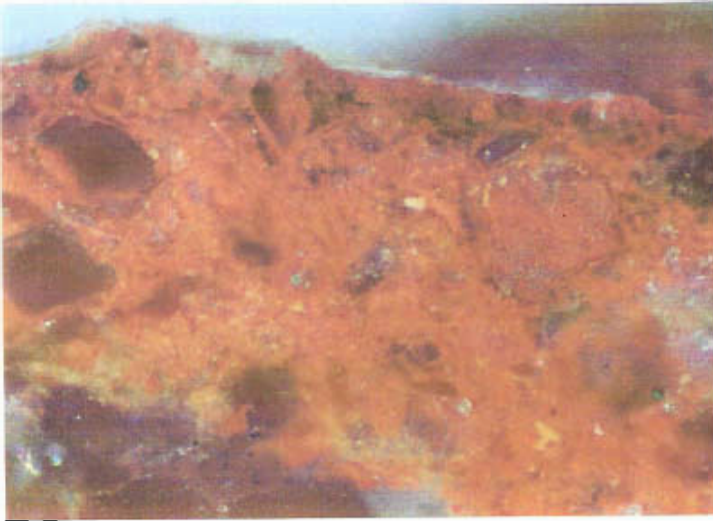
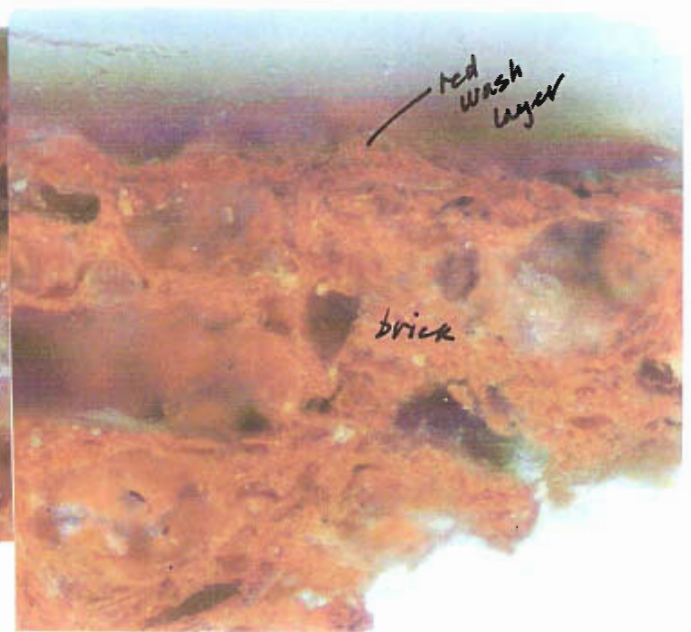
Visible Light 125X

Sample VIII-2. Brick face 3” below south (right) front window sill, first floor.

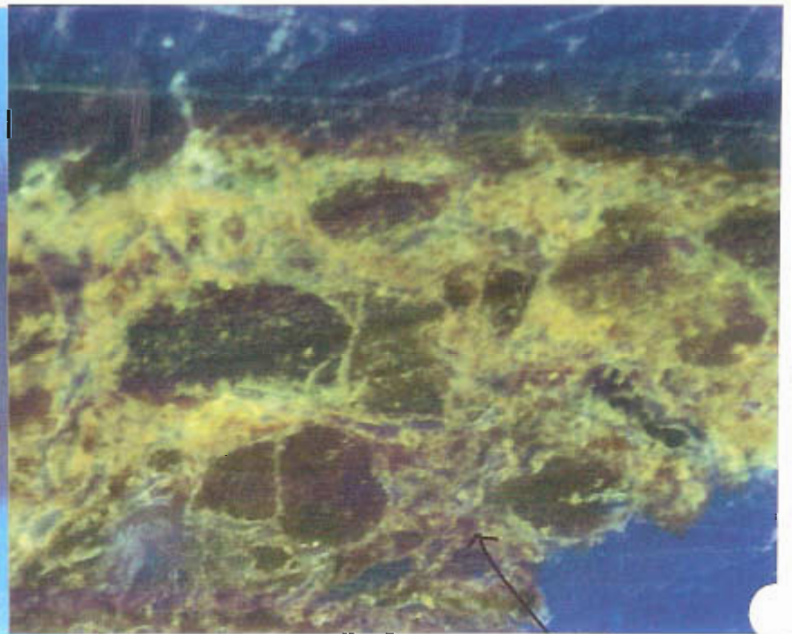
UV Light & FITC 125X
For the presence of proteins

Fluorochrome binding media testing produced a strong positive reaction for the presence of proteins in the brick substrate and a weaker positive reaction for proteins in the red wash layer. This reaction suggests there was a protein component in the red wash that leached into the porous brick substrate when the red wash was applied. Pigment identification with polarized light microscopy analysis revealed the presence of red ochre, calcium carbonate and scattered red lead particles (see the photomicrographs on page 10).

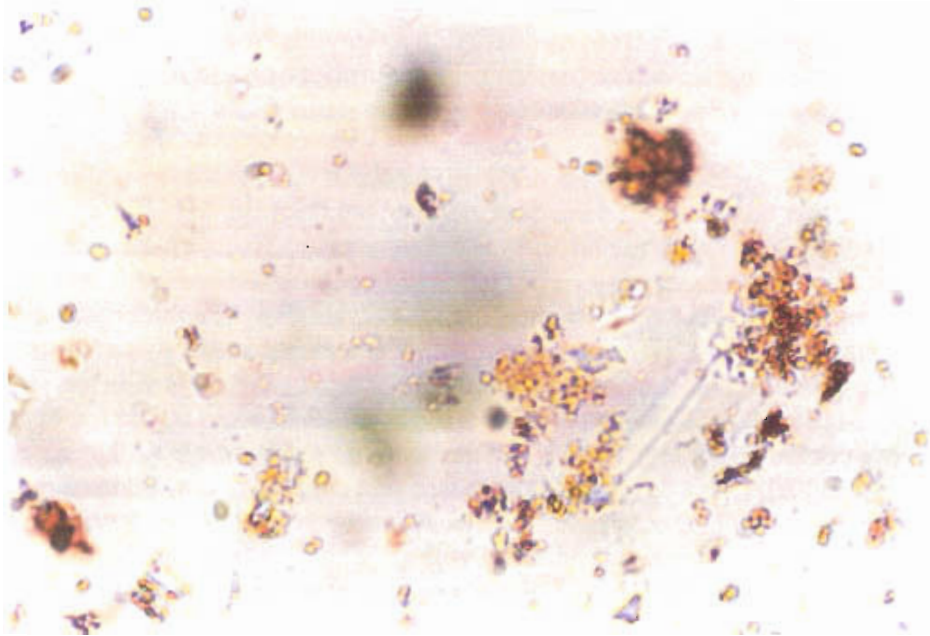
Plane Polarized Transmitted Light 1250X

Sample VIII-2. Brick face 3" below south (right) front window sill, first floor. Dispersed pigments from red wash layer.
