Sample VIII-3. Brick face, south (right) side of loggia, 2” back from engaged column and 2” in front of column (two nearby locations). This area was identified by Dr. Lynch as representative of later campaigns, using red-pigmented limewashes, to clean up brick surfaces compromised by repairs or untidy repainting of the exterior woodwork.¹³ Visual inspection at 30X magnification showed that there are grayish lumps of paint adhered to the brick which have been covered over with thin reddish coatings. These paints could have dripped down from an earlier cornice painting project or could have splashed onto the brick when the columns were painted.

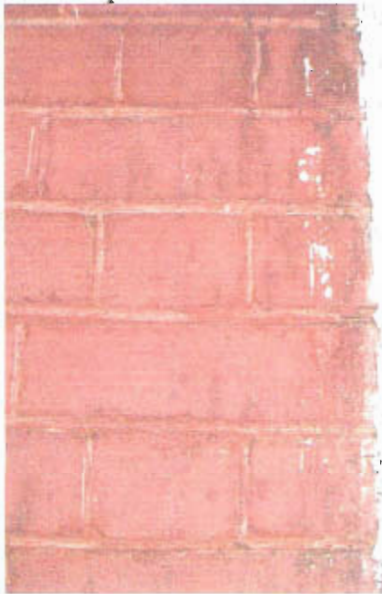
Paint drips on brick at Pavilion VIII

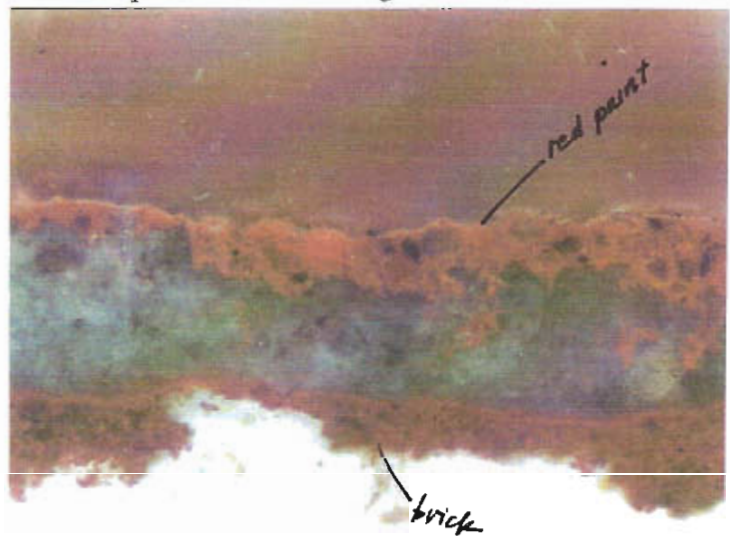
Sample VIII-3 Visible Light 50X

The cross-section samples taken from this area show that there is a coarse, slightly translucent grayish layer on top of the brick surface, but there is no evidence of the thin deep red wash layer on top of the brick, as noted in sample VIII-2. There is a thin, dull red, opaque, matte-looking coating on top of the gray paint which probably was applied to disguise the messy paint drips. Binding media analysis showed a faint positive reaction for the presence of proteins in the uppermost reddish layer only and a very strong positive reaction for the presence of oils in the brick substrate and in the uppermost red paint layer. The oil reaction in the brick could be an indication of a maintenance coating of oil on the brick and mortar (also see sample I-1). Unlike the red wash in sample VIII-1, this red paint is composed of a combination of pigments – primarily red ochre, with charcoal black, silica, and calcium carbonate (added as filler). The opacity of the red layer, in combination with its strong reaction for the presence of oils, suggests it is an oil-based paint, not a limewash. The translucent gray layer may be a coarse pigmented limewash, possibly an early coating for the portico columns.

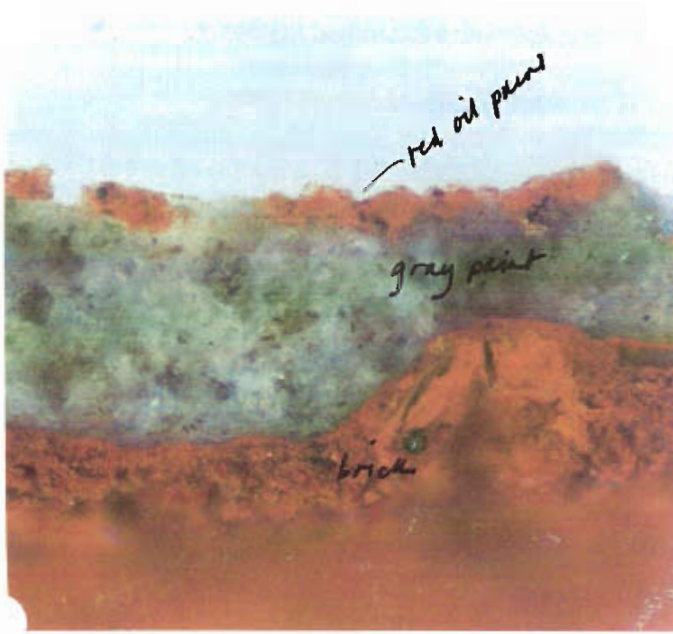
Visible Light 125X

Sample VIII-3. Brick face, south (right) side of loggia, 2" back from engaged column and 2" in front of column (two nearby locations).

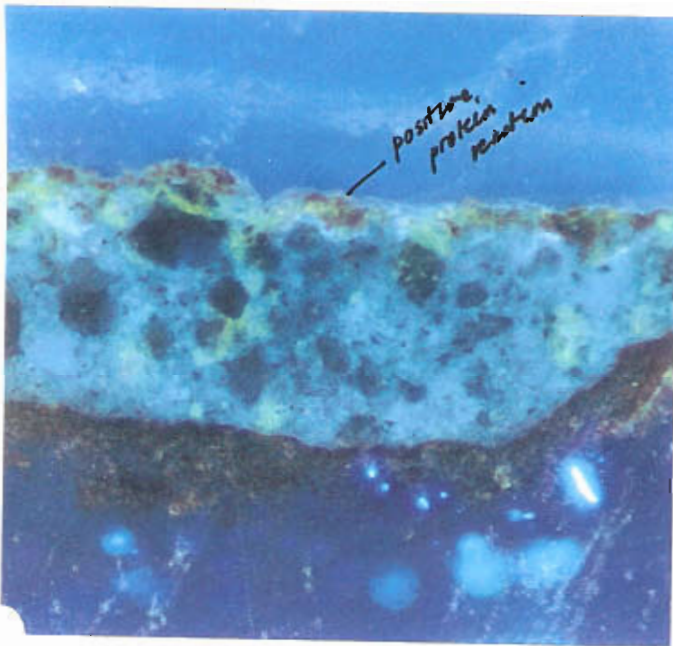
UV Light & EITC 125X
For the presence of proteins

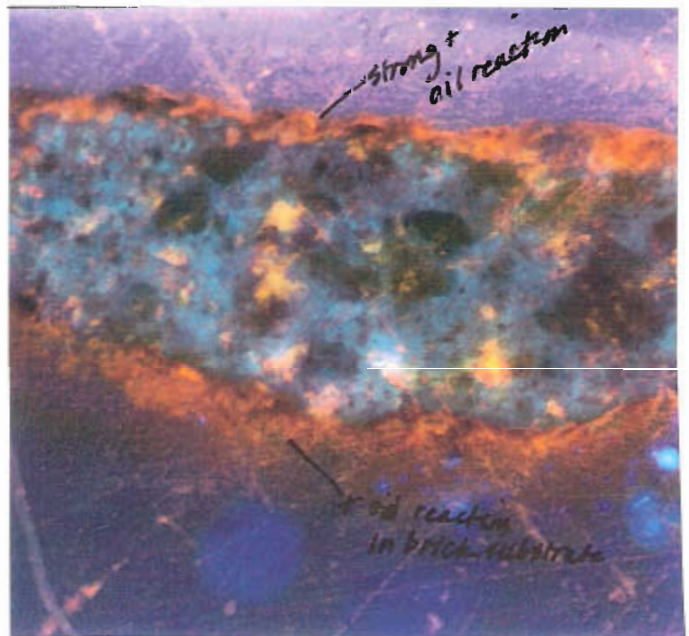
UV Light & RHOB 125X
For the presence of oils
